**SAS Superstructure**

**Daily Diary Report by Bid Item**

Contract No.: 04-0120F4

Diary #: 396 Const Calendar Day: 738 Date: 16-Sep-2011 Friday

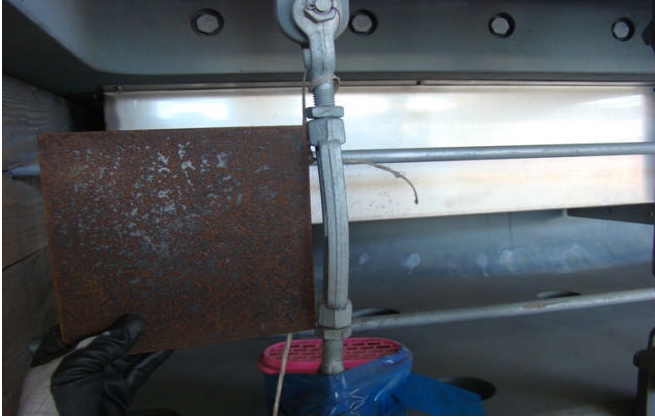
- Turnbuckles used to fasten the upper housing to the lower housing buckled due to the side impact load of the slip movement.
    - Timbers used to vertically support the upper housing to the lower housing for Shear Keys S3 and S4 had shifted towards the direction of movement.

Bent turnbuckle seen after the jack slip failure on the southeast corner of Shear Key S4.

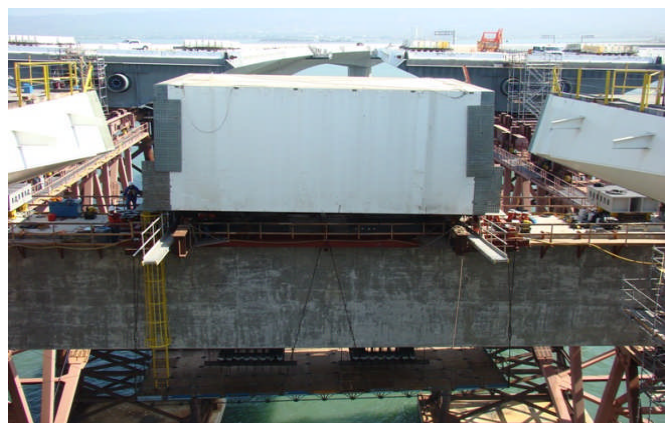
Crossbeam 18 seen from the middle of Crossbeam 17 looking east.

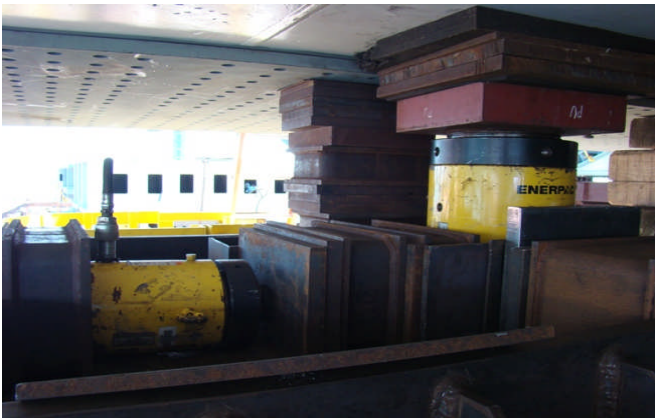
Additional steel shim plates used to shore the northwest jack under Crossbeam 18 prior to attempting further jacking operations.

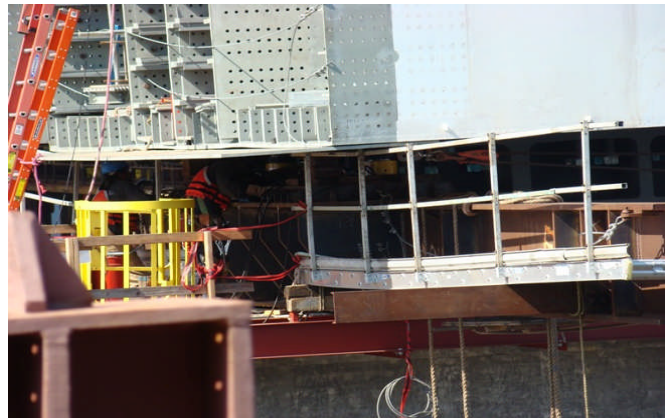
- Access platforms sustained bending damage to the handrails.
    - There may have been some bending damage to the Crossbeam where the jack slip failure occurred.

Southern end of Crossbeam 18 that bent the working platform railing after the slip, also ABF ironworkers were seen adding additional supports.

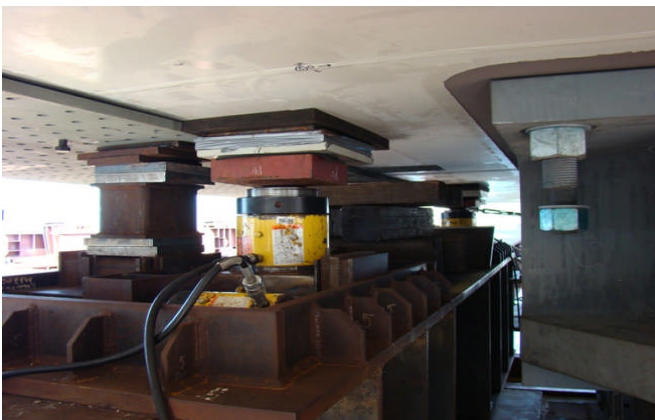
Additional shim plates and timbers used to shore the northern end of Crossbeam 18 prior to attempting further jacking operations.

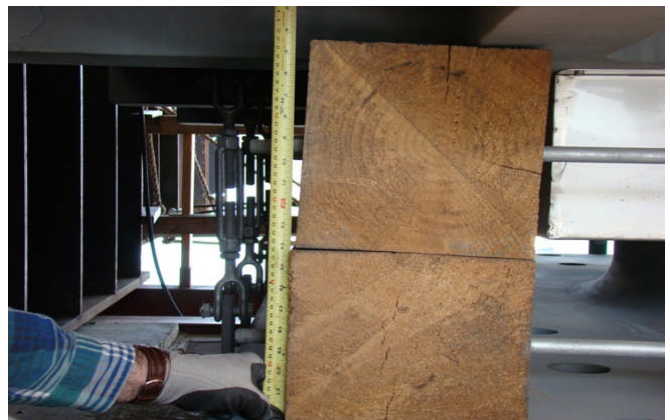
A dramatic shift in the northern support timbers for the S3 Shear Key were observed after the jack slip failure.

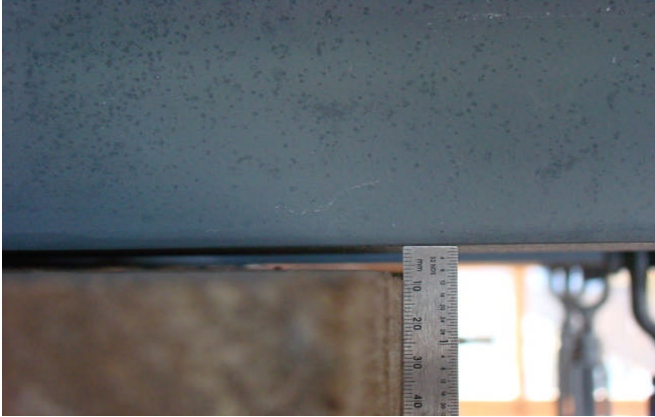
A rotation of 1/4" in the upper housing was observed for the S4 Shear Key referencing the support timbers on the northern end of the shear key.

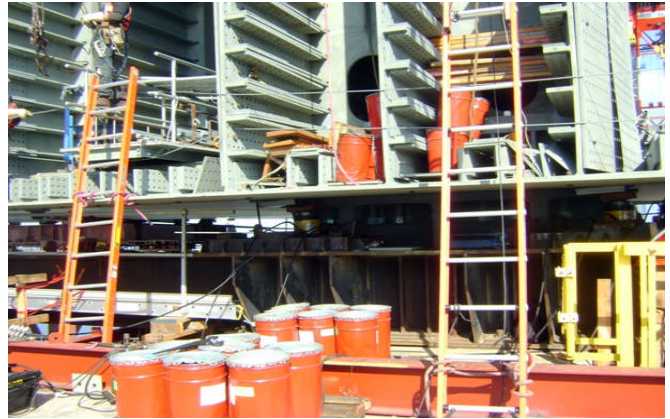
Photo taken by Tai-Lin Liu of the slippage in the two south jacks while ABF ironworkers were adjusting Crossbeam 18.

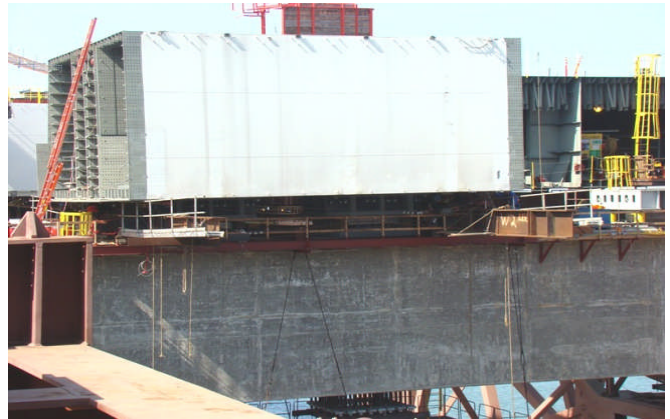
- No significant damage was seen on the lower housing base plate of Shear Key S4 where Crossbeam 18/Shear Keys S3 and S4 rested after the jack slip failure on the south end.

Crossbeam 18 bearing on the south portion of Shear Key S4 base plate, due to inadequate horizontal support of 2 jacks on the south support beam.

- 3.) The remainder of the day was spent shoring Crossbeam 18 and relieving the bearing stress on the southern portion of the bottom base plate of Shear Key S4.

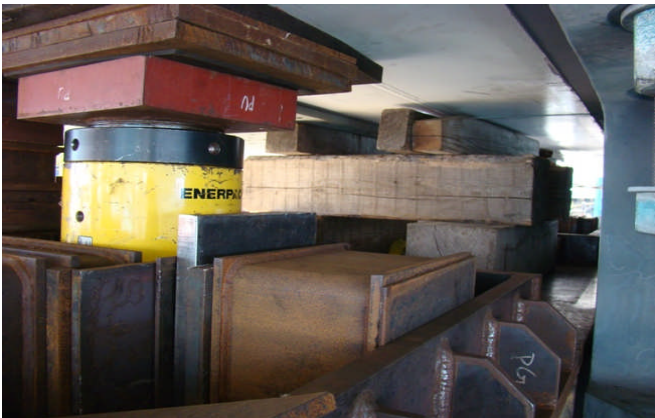
Additional shim plates and timbers used to shore the northern end of Crossbeam 18 prior to attempting further jacking operations.

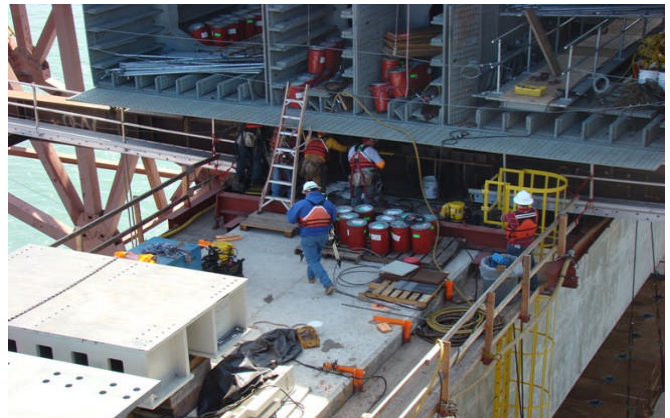
ABF ironworkers adding additional supports after the jack slip failure to relieve the bearing pressure on Shear Key S4.
